# Manhole Inspection Summary

Manhole # S31WW\_004MH

Insp Date: **5/30/07 9:32 PM**

**Location** Address: **3100 REMINGTON AVE**

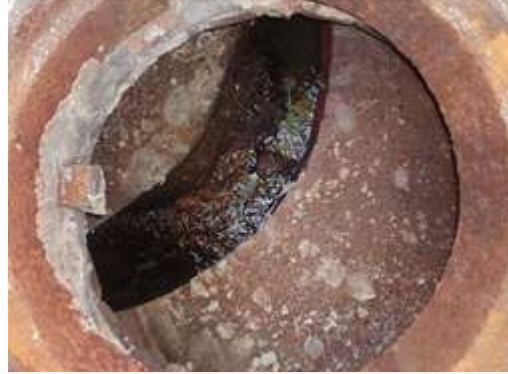
Top View

Evidence of surcharge - Bench debris.  
Channel debris.

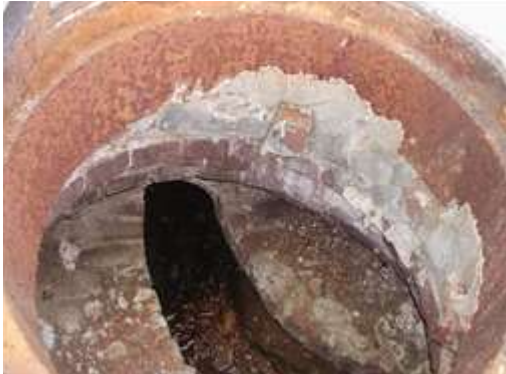
Defect

Frame leaks. Adjustment deterioration  
and infiltration. Corbel and Barrel  
infiltration.

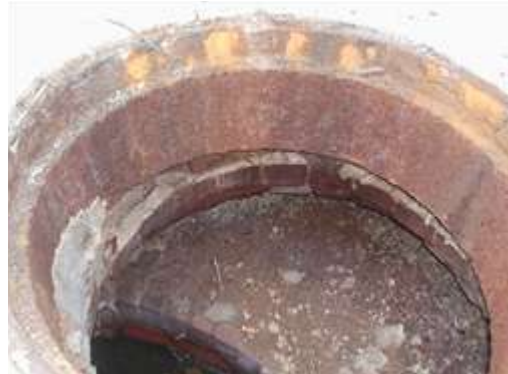
Defect

Frame leaks. Adjustment deterioration  
and infiltration. Corbel and Barrel  
infiltration.

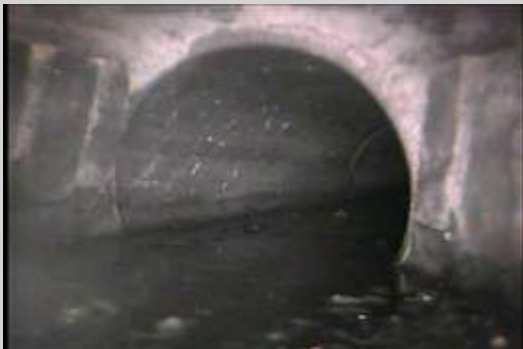
### 8 in. Circular Gravity Sewer Pipe In @ 8 O'Clock

Deposits: ☐ None ☒ **Mud** ☐ Sludge ☒ **Debris** ☐ Grease

Silt Depth: **0** (in.) Deposits Extent: **Light**
